# Single tooth implant in combination with orthodontics

Armin WATZER-HERBERTH

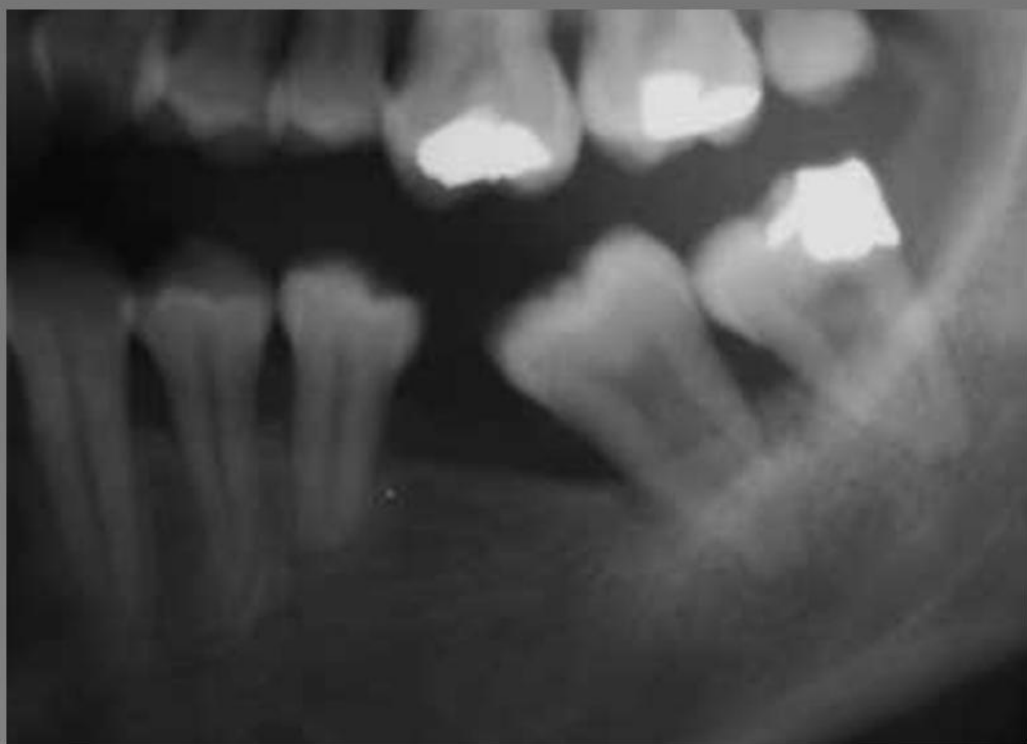
Fig. 1: The initial X-ray:  
36 is missing,  
37 is tipped anteriorly into the gap

A 40 year old female was referred for a missing tooth 36 by her periodontologist. The tooth 37 was anteriorly tipped. The tooth 35 had a short root and was not deemed fit for a conventional bridge. The tooth 38 as well as the opposing tooth 28 were planned for extraction by the referring dentist for periodontical reasons.

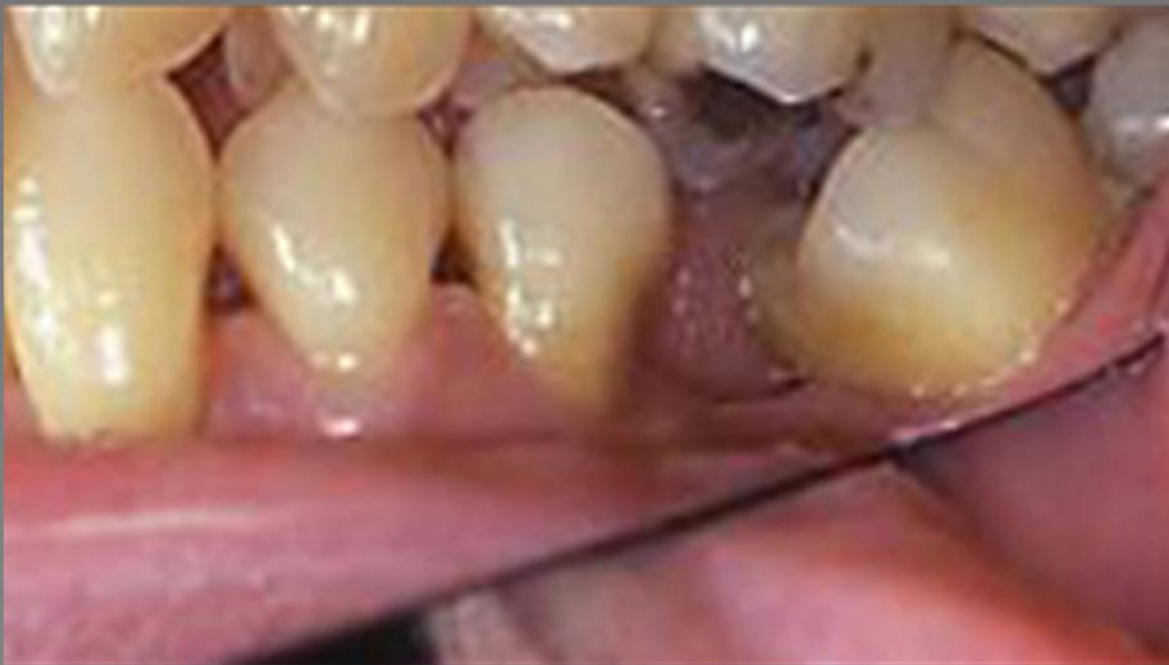
Fig. 2: Lateral view  
before therapy was started

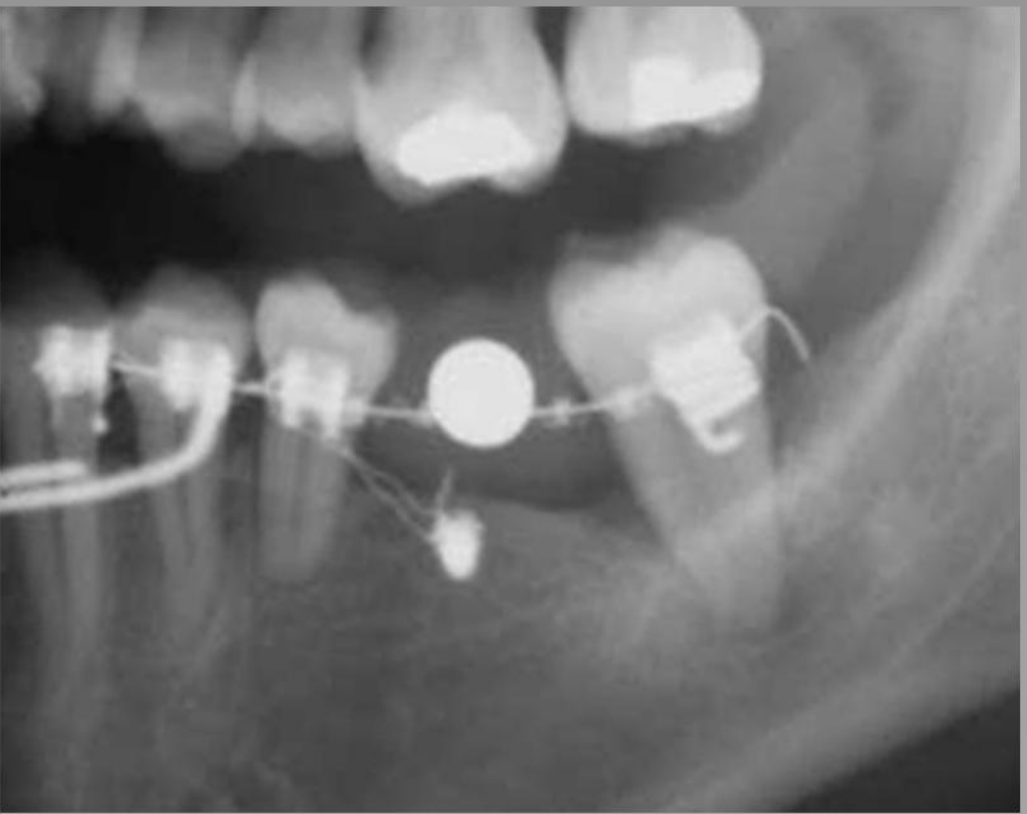
Fig. 3: X-ray during orthodontic  
treatment, before the insertion of a  
Xive implant. A 5 mm steel ball for  
calibration can be seen.  
The DualTop micro implant is visible.

A fixed orthodontic appliance was introduced. To lessen the strain on the tooth 35, anchorage was secured by a micro implant (DualTop<sup>®</sup>, length 8mm, diameter 2mm). It was inserted buccally into the alveolar ridge, at the site of the missing molar 36.

The tooth 37 was uprighted gradually. At that time the tooth 38 had already been extracted which made it easier to distalise the crown of the tooth 37. Due to occlusal interference, however, it took 8 months until it was completely upright.

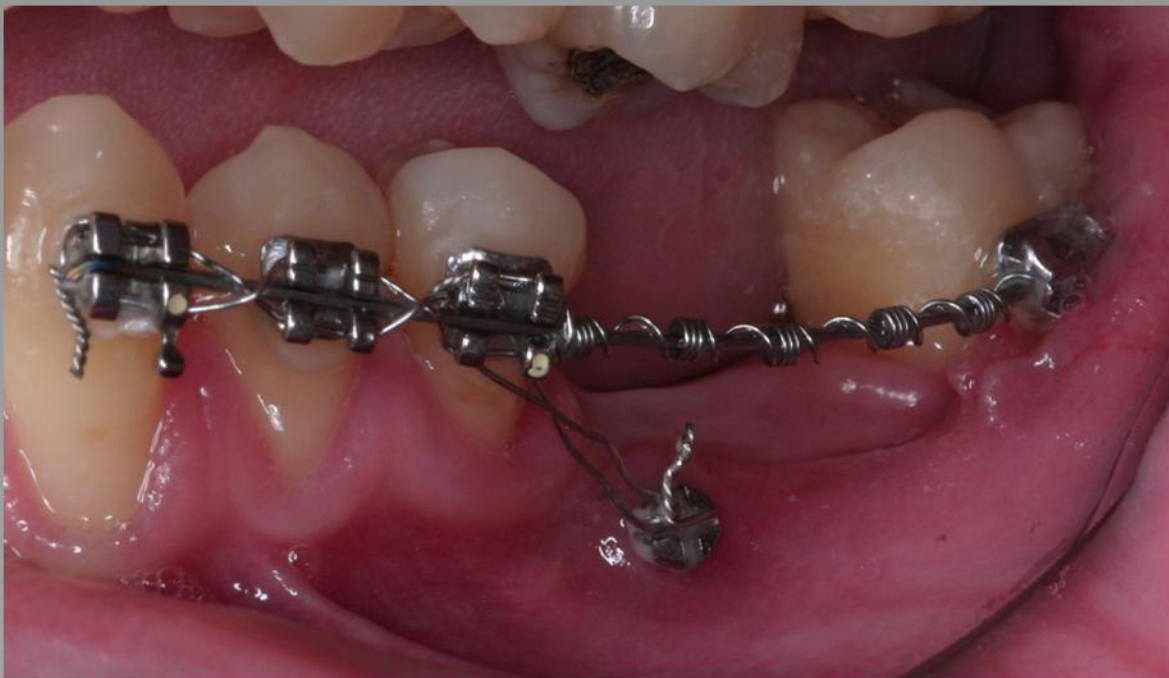
Fig. 4: Lateral view during  
orthodontic therapy - the DualTop  
micro implant is fixed to the tooth 35.

A good result was achieved. It would have been easier to upright the molar 37, if the microimplant would have been inserted distal to the tooth. However that was not possible because of the very mobile gingiva in that area. Therefore a block was formed between the microimplant and the tooth 35, against which the tooth 37 was tipped backwards and uprighted. As expected, no problems were encountered when the Xive implant was inserted at the same region where the microimplant had been. The tooth 35, with its short root had not increased its mobility.

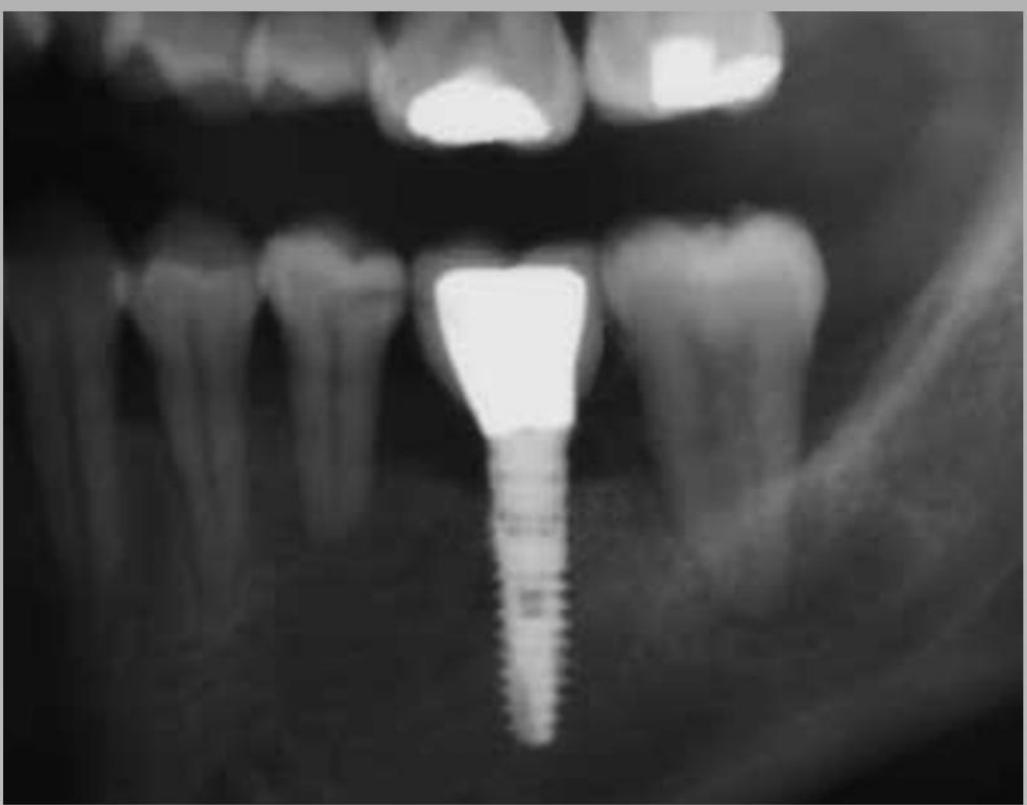
Fig. 5: X-ray at the end of treatment -  
a Xive implant is replacing the tooth 36.

After orthodontic treatment, a Xive<sup>®</sup> implant (length 13mm, diameter 3.8mm) was inserted to replace the tooth 36. The micro implant was removed simultaneously. After a healing-time of 3 months, an EstheticBase<sup>®</sup> abutment was fixed to the Xive<sup>®</sup> implant onto which a crown was cemented (Dental laboratory: Zahnlabor Dieter Ribarich, Baden bei Wien).

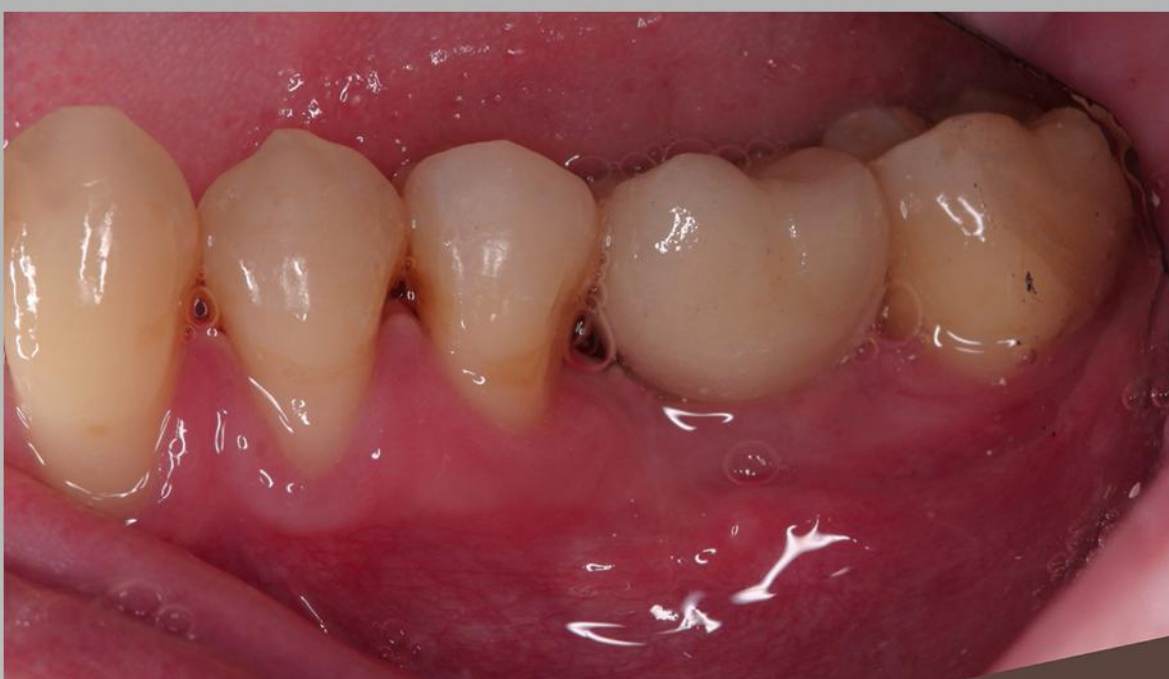
Fig. 6: Lateral view at the end of  
treatment - a crown cemented on a  
Xive implant is replacing the tooth 36

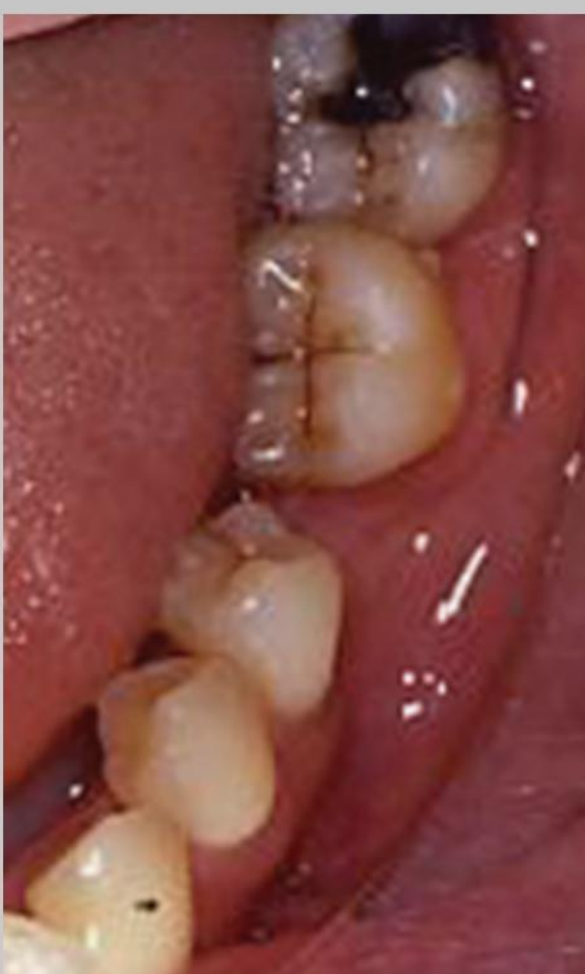
Fig. 7: Occlusal view before  
therapy was started

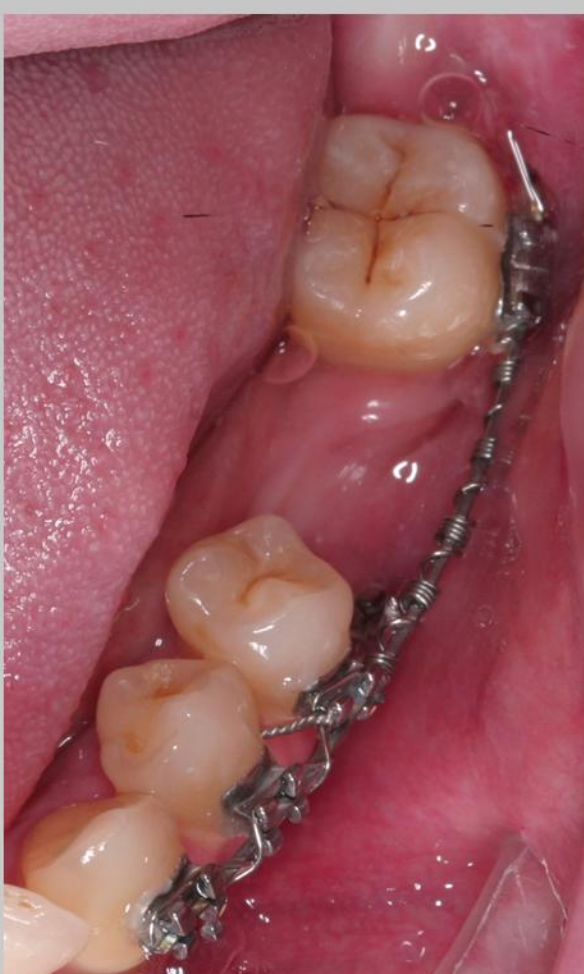
Fig. 8: Occlusal view during  
orthodontic therapy

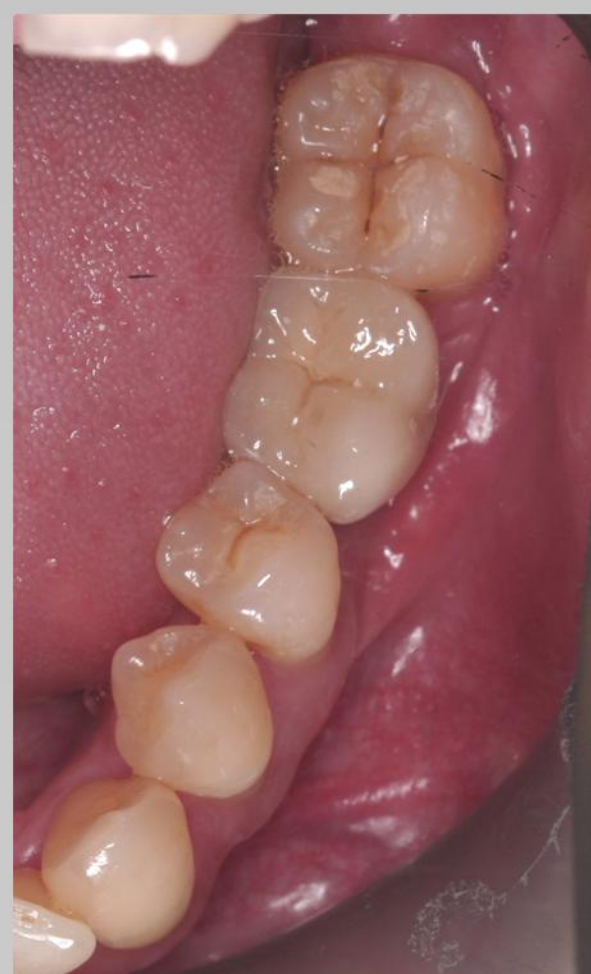
Fig. 9: Occlusal view at the end  
of therapy
